MUNDY TOWNSHIP

Windfield Estates Subdivision

Road Repair Estimate

April 28, 2014

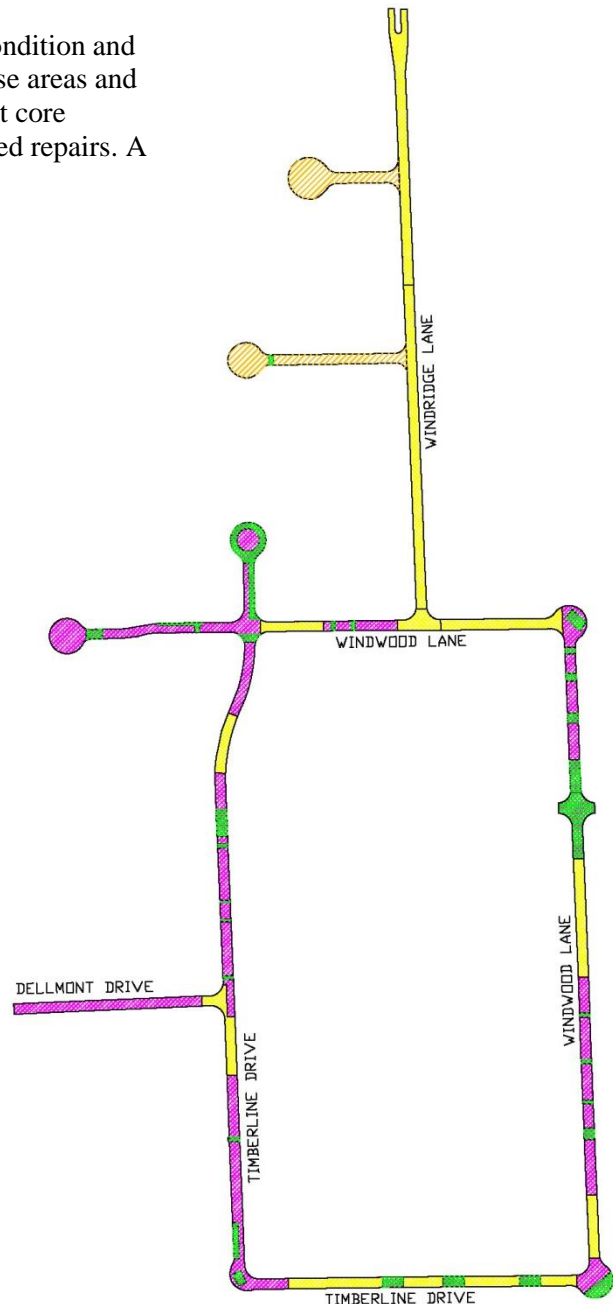
During our field review of the existing roadways, the condition and proposed improvements were noted. During design, these areas and proposed improvements will be more defined. Pavement core information will also be utilized to help determine needed repairs. A larger scale drawing can be provided, as requested.
